Fastener Integrity is Key to Smooth Railway Traffic

THU locknuts reduce maintenance and ensure track availability for Class 1 railway

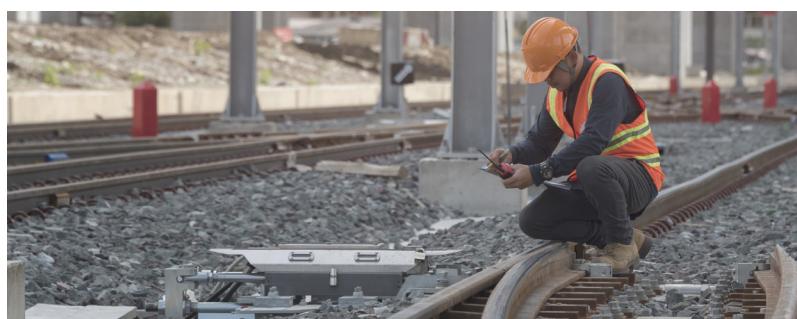
Track inspection

After trying various locking washers, rivet-type bolts, and conventional locknuts, the only reliable method for keeping traffic moving and ensuring the integrity of the diamond was to schedule daily on-site maintenance inspections to re-tighten loosened bolted joints. In winter, the crew had the added responsibility of transporting equipment to blow snow from the track to carry out the maintenance.

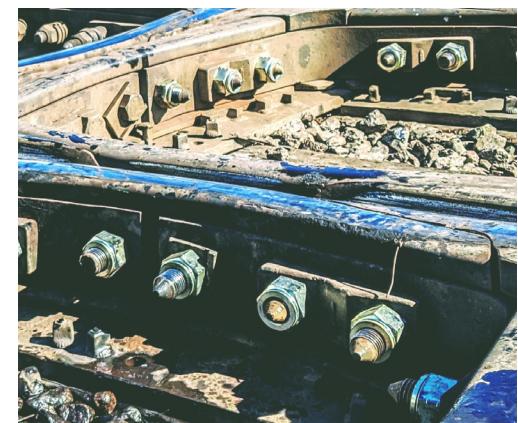
THU installed on Class 1 diamond

In December 2017, operators sought to eliminate the need for these daily maintenance visits. Working with J.Lanfranco, they installed 1"3/8UNC Gr.8 THU locknuts using existing track bolts on both interior and exterior locations. The nuts were torqued to existing values and then monitored — at first daily, then monthly.

After more than three months with no movement or loosened nuts, heel blocks and steps were also outfitted with THU locknuts. In February 2019, after being subjected to two freezing and thawing cycles, **none of the installations experienced any loosening**. And best of all, standard bolts, tools, and installation procedures were used by the crews.
